Our friends at JetTech Mechanical conducted routine vibration analysis on three boiler feed pumps at SRP Agua Fria Generating Station, a natural gas facility in Glendale, Arizona.

Observed Vibration Phenomenon

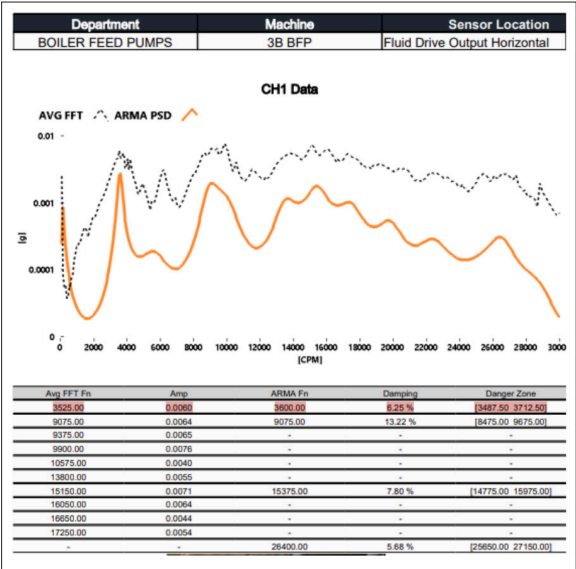
Fluid Drive Output Shaft:

Vibration monitoring revealed that the fluid drive’s natural frequency resonance in the horizontal direction lies between 3487 and 3712 RPM. With the motor operating at a constant 3600 RPM, within critical range, resonant amplification occurs horizontally, with a damping ratio of 6.25%. The danger zone is defined as 3487-3712 RPM.

This resonance corresponds to a lateral natural frequency of the fluid drive rotor-bearing system. When the excitation frequency coincides with this natural frequency, vibration amplitudes rise significantly. The damping factor of 6.25% indicates limited energy dissipation, leading to pronounced resonance. The motor’s synchronous rotation produces a constant forcing frequency of ~60 Hz (3600 RPM).

Horizontal resonance was identified within the 3487-3721 RPM range, confirming the horizontal critical speed region. The vertical response exhibited lower amplitude and did not demonstrate significant resonance.

Adjust operating points to avoid prolonged operation in 3487-3712 RPM range

Investigate damping enhancements (e.g. squeeze-film dampers)

Verify shaft alignment and balance

Explore structural modifications to shift the natural frequency

Continue vibration monitoring with alarm limits for horizontal vibration

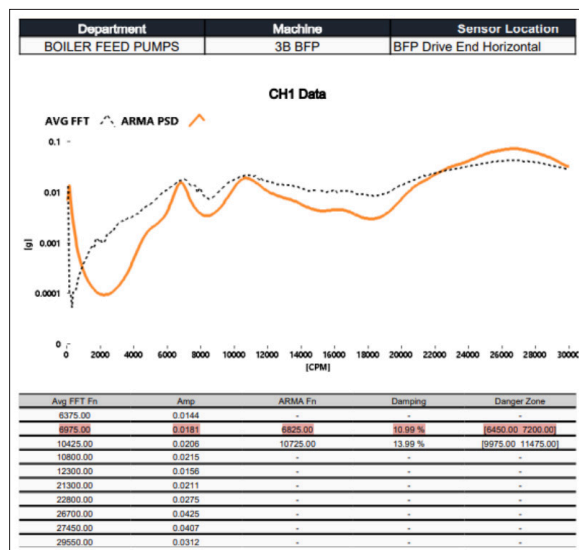
Boiler Feed Pump:

The horizontal direction displayed some amplification near the fluid drive resonance; the vertical direction showed no notable resonance.

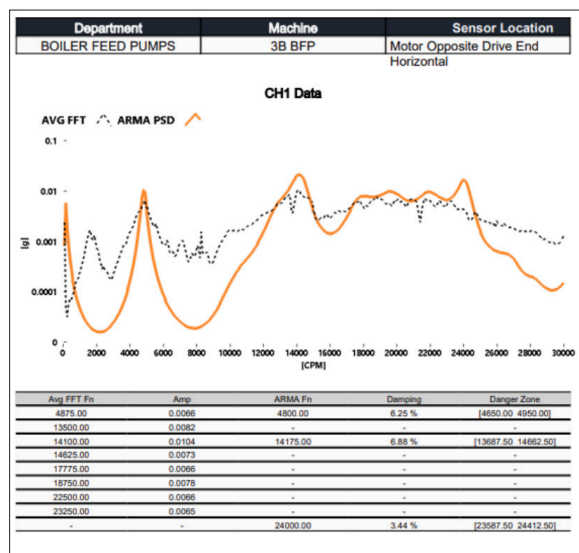
Motor Non-Drive End:

Moderate horizontal response was recorded, but no dominant resonance was present. The vertical response remained stable with minimal amplification.
