Case Study: Wireless Condition Monitoring Deployment at Arizona Mining Operation

Overview

A large mining operation in Asarco, Arizona partnered with Machinery & Reliability Institute (MRI) to modernize its reliability program using wireless IIoT technology.

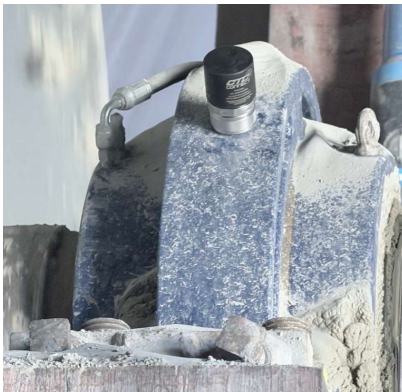
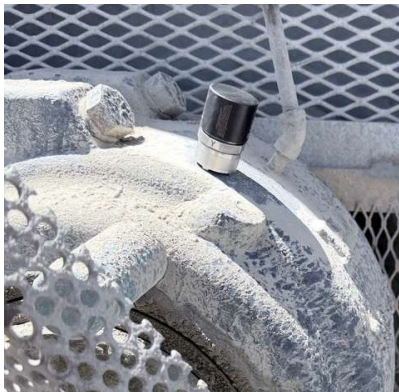
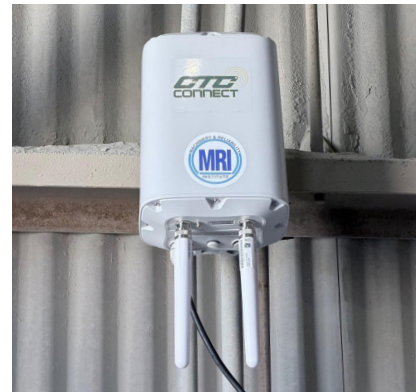
WS300 Series ConnectSens™ Wireless Sensors

- » Dynamic triaxial vibration and temperature monitoring
- » IP67 rated and well suited for long-term reliability in harsh mining environments

MH214-3A Mounting Magnets

- » Enables fast, secure installation on rotating equipment
- » Eliminates the need for drilling or permanent modification

ACCESS2000 Series Long-Range Wireless Gateway

- » Centralized data aggregation and transmission
- » Scalable architecture for expanding sensor networks
